Dimpled Ball Grid Array Qualification Testing for Space Flight Applications

Sharon L. Barr
Atul Mehta
Jet Propulsion Laboratory
California Institute of Technology
4800 Oak Grove Drive, M/S 103-106
Pasadena, CA 91109
(818) 393-3210
FAX (818) 393-6994
sharon.l.barr@jpl.nasa.gov

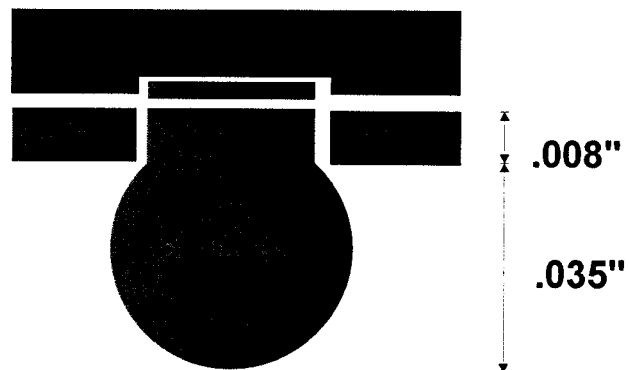
Figure 1. Solder joint on a Dimpled BGA

The part being qualified was a 472 Dimpled BGA package. D-BGAs are similar to regular BGAs with a small column, or dimple, between the ball and the package, see Figure 1. The D-BGA package was chosen since its reliability margin was higher than standard BGA packages or even Column Grid Arrays. The packages were internally daisy chained and balled by Honeywell. The majority of the D-BGA packages had Sn60/Pb40 solder balls, with a small portion having Sn46/Pb46/Bi08 solder balls for comparison.

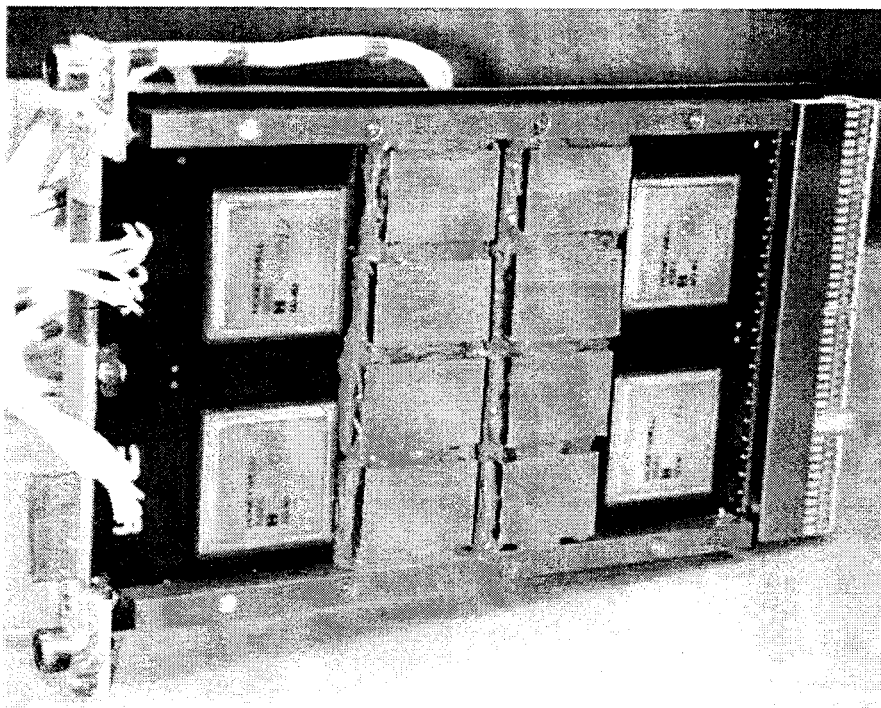
Figure 2. D-BGA Test Assembly

The test article was a printed wiring assembly (PWAs) with two to four D-BGA packages, see Figure 2. The PWA was designed to represent a 3U CompactPCI® slice. See Table 1 for PWA test designation. The test PWA was designed such that when the D-BGA was attached, four daisy chains per package were formed.

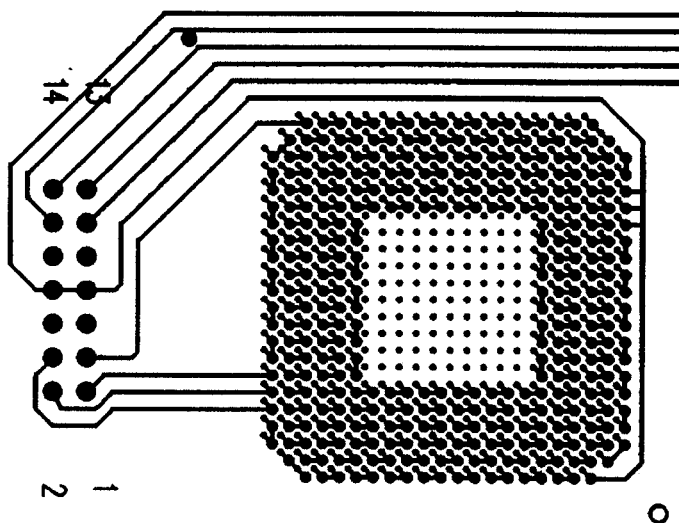
Figure 3. Art work on PWB

Part of PWB daisy chain is shown in Figure 3. Dummy parts were placed on the backside of the PWA to simulate a double sided assembly. The D-BGAs were placed on the PWB in the approximate locations as flight. The thermal cycling PWAs had test connectors installed on the board for electrical monitoring. The shock and vibration test boards had wires soldered to the board for electrical monitoring. These board also had heat sinks, Card-locs, CompactPCI® connectors, and a front panel.

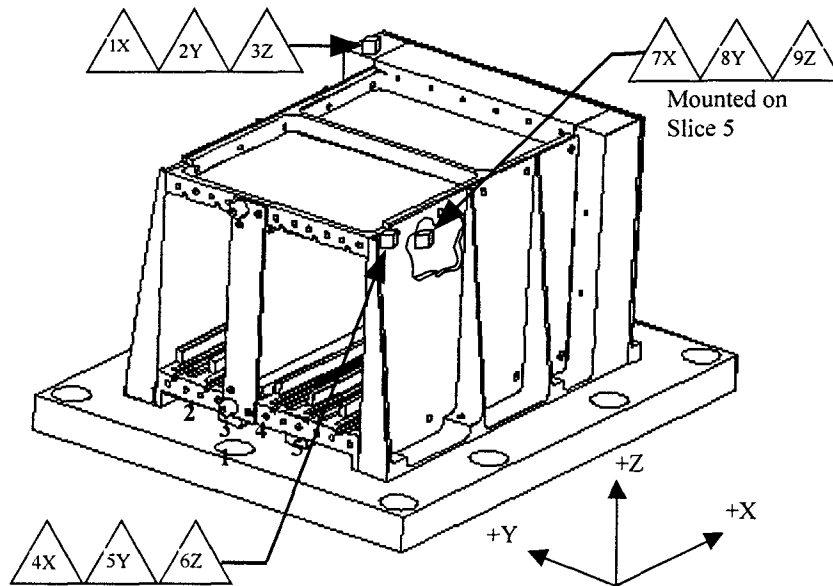
Figure 4. Vibration & Shock Test Chassis

An Aluminum, six slot flight-like chassis, with a mounted backplane was used for the shock and vibration tests. There were five PWAs installed in the chassis, two of which were D-BGA boards. The test axes and accelerometers are shown in Figure 4. The backplane was a six slot, 3U, PWB (see Figure 5) with installed CompactPCI® connectors. Its design was based upon the CompactPCI® specification PICMG 2.0 R2.1.

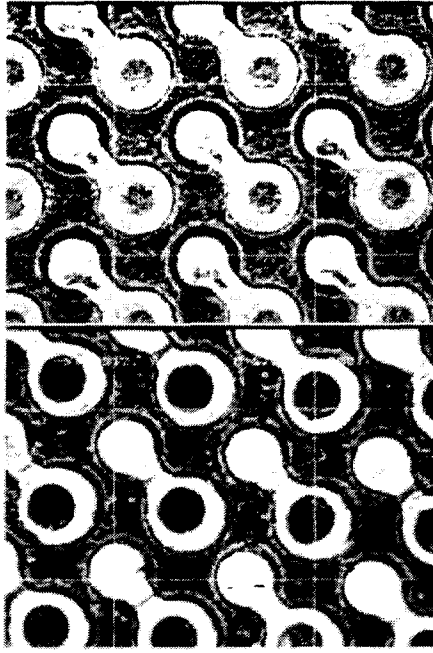
Figure 6. Solder Mask

The first batch of PWAs assembled did not have solder mask on the vias and traces directly connected to D-BGA pads. The second batch of boards were procured with solder mask on the vias and traces. See Figure 6. A coplanarity check was performed on the D-BGA parts with a maximum delta in the height of 0.004”. See Table 3 for typical coplanarity data. The PWB was checked for solderability using a SERA tester. The D-BGAs and PWBs were tested for continuity (open and short test) prior to assembly to assure the integrity of the daisy chains. The PWBs were cleaned in an ECD 7300 batch cleaner using a DI water soaponifier wash cycle and a DI water and isopropyl alcohol rinse, then vacuum baked at $100^{\circ}\text{C} \pm 10^{\circ}\text{C}$ for 8 hours.

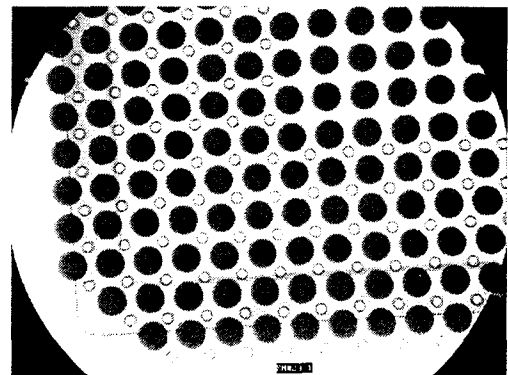
Figure 9. X-ray of D-BGA

The outer solder balls were visually inspected using both a conventional microscope and also an ERSAScope optical inspection system, see Figure 8. The assembly appeared to be free of residue and the outer rows showed good wetting. Real time X-ray was also used to check for missing solder balls, shorts, voids, pad to ball alignment and reflow problems. Figure 9 is an example of one of the X-rays.

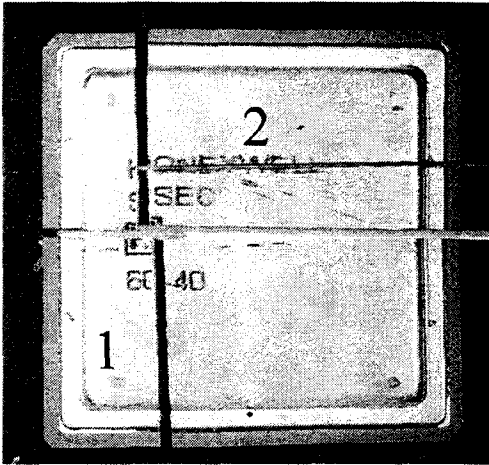
Figure 10. D-BGA Cut into Pieces #1 and #2

S/N 008 was used as a thermal profile board and was also used as a control sample for cross sections. Figure 10 shows how the samples were cut from two sections. Figures 11 and 12 show typical cross sections of the control sample. These cross sections indicated that there is a small amount of separation between the dimple and the package.

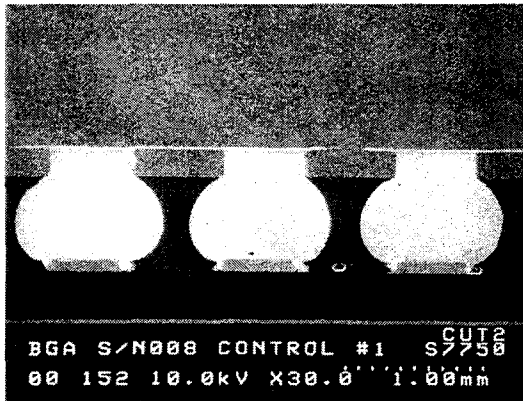
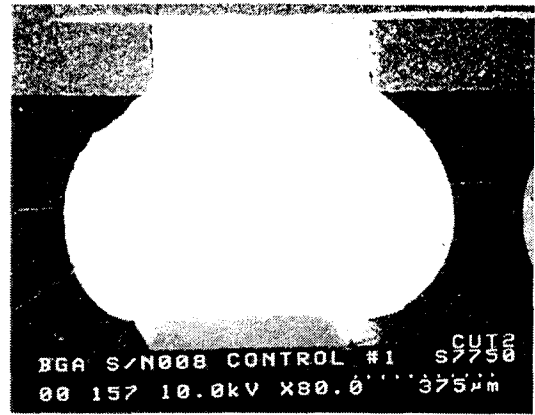
Figure 11. D-BGA Cross section, Control Piece #1

Figure 12. D-BGA Cross section, Control Piece #1a

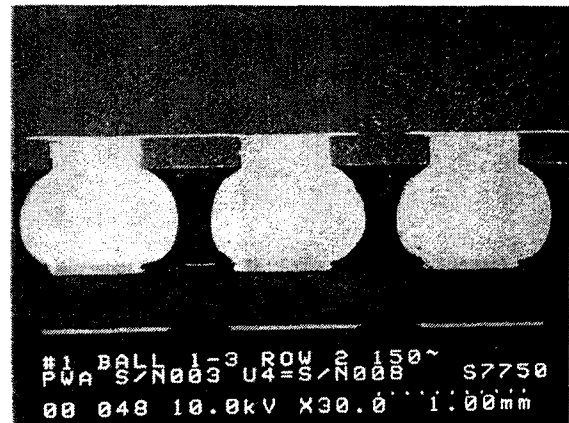
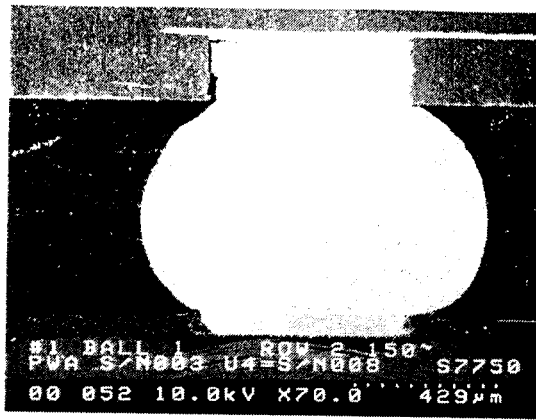
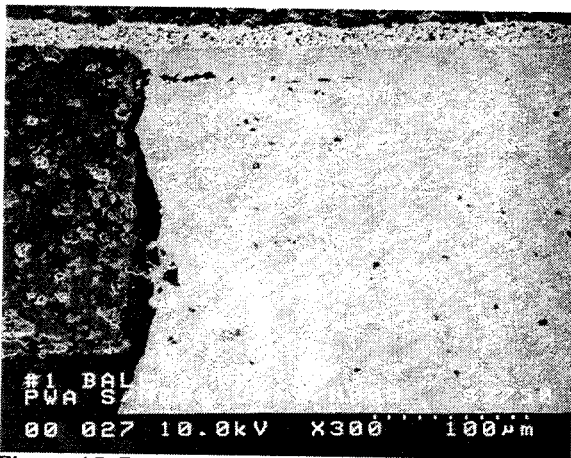
Figure 13. D-BGA Cross Section, 150 thermal cycles

Figure 14. D-BGA Cross Section, 150 thermal cycles

Figure 15. D-BGA Cross Section, 150 thermal cycles

All thermal cycle tests were conducted with no intermittents. The cross section data indicates some signs of cracking or separation at the point where the solder ball and the solder mask meet at the PWB. Cross sections were taken on one sample from S/N 003 at 150 thermal cycles. Figures 13 through 15 show an example of the separation between the dimple and the package. It appears that thermal cycling propagates this separation and may be a weak point. Figures 16 and 17 indicate an additional weak point; where the solder ball meets the solder mask. This crack disappears as the cross sections moves to the center of the ball. This will be discussed again further in the paper.

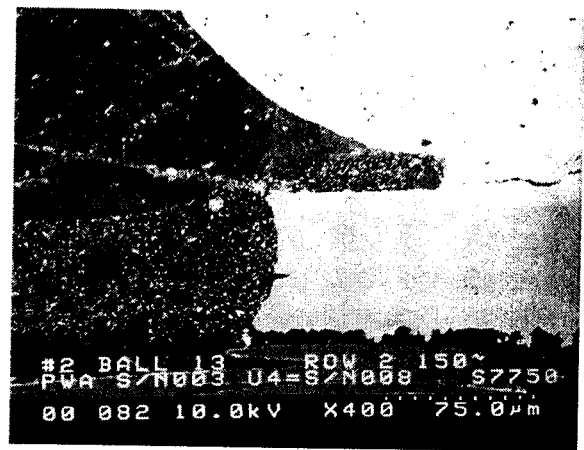
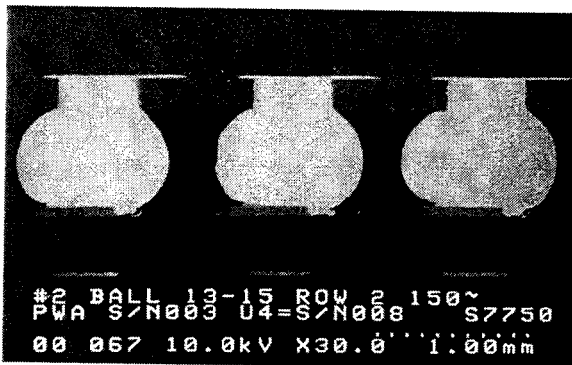
Figure 17 D-BGA Cross Section, Solder mask effect

Figure 16. D-BGA Cross Section, Solder mask effect

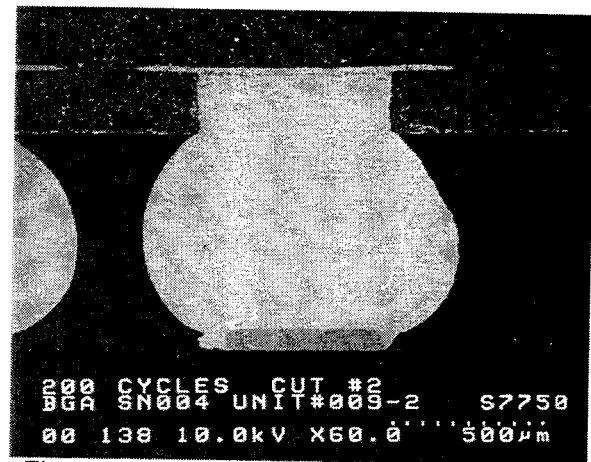
Figure 18. D-BGA Cross Sec, 200 thermal cycles, Typical

Cross sections were taken on one sample from S/N 003 (Polyimide) and S/N 004 (Aramid) at 200 thermal cycles. Figure 18 is a typical cross section after 200 thermal cycles. Figure 19 shows the same anomalies as mentioned above.

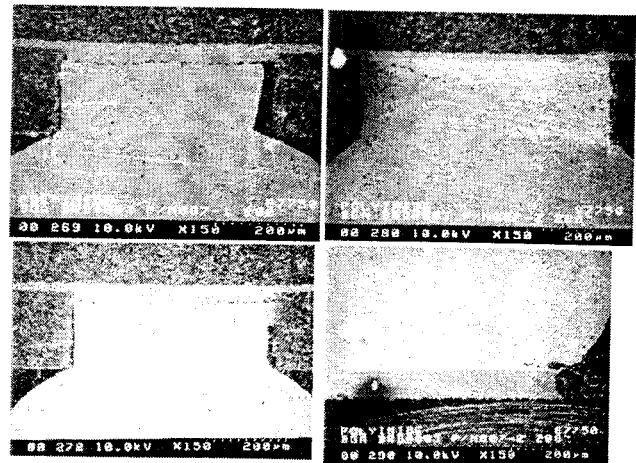
Figure 19. D-BGA Cross Section, 200 thermal cycles, anomalies

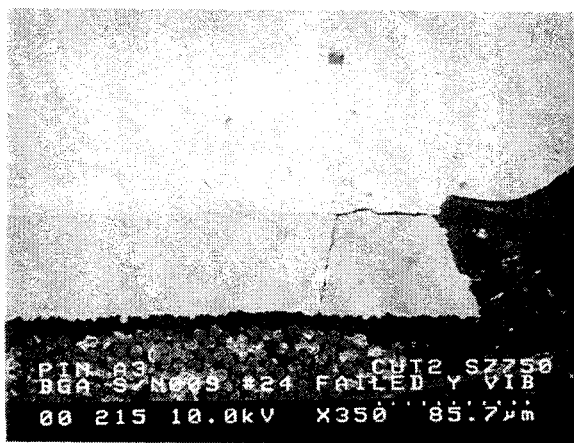
Figure 20. Cross Section of D-BGA A3, Cut 2

The cross section of the crack caused by the mass impact is shown in Figure 20. There were no signs of solder degradation, which would be evidence of a fatigued solder joint from the vibration test. Figure 21 shows a typical cross section. Cross sections were also conducted on two other parts on S/N 009. The cross sections revealed minor voiding at 500X that were likely caused by oxidation on the PWB pads during the fabrication process, see Figure 22. One part showed slight cracks at the ball to pad interface in a few locations near the corners, while another part had no cracks.

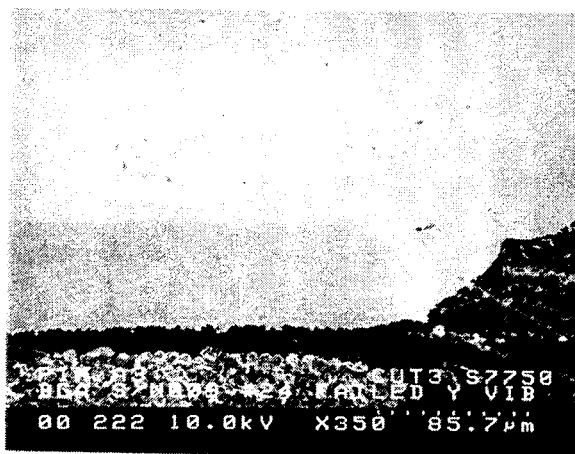
Figure 21. Typical Cross Section of D-BGA

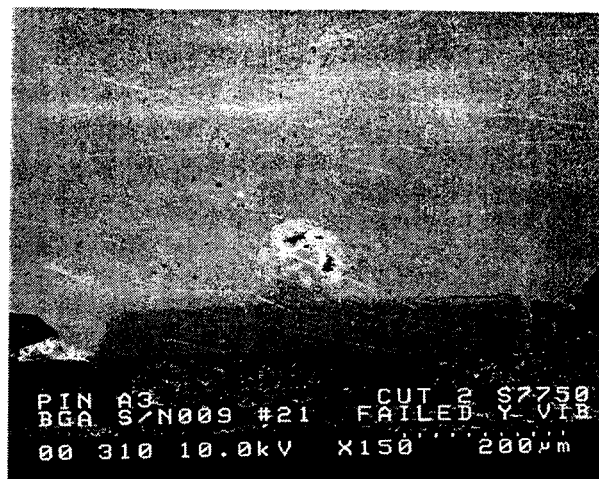
Figure 22. Typical Cross Section, D-BGA, S/N 009-21
